**Updated Environmental and Social Impact Assessment (ESIA)
for
the Uitkijk Appraisal Drilling Program
(ADP) 2018**

Staatsolie Maatschappij Suriname N.V.

Paramaribo, 15 November 2018

Project Title: Environmental and Social Impact Assessment (ESIA) for the Uitkijk Appraisal Drilling Program (ADP) 2018
 Project Number: IS-344
 Document: ESIA Report

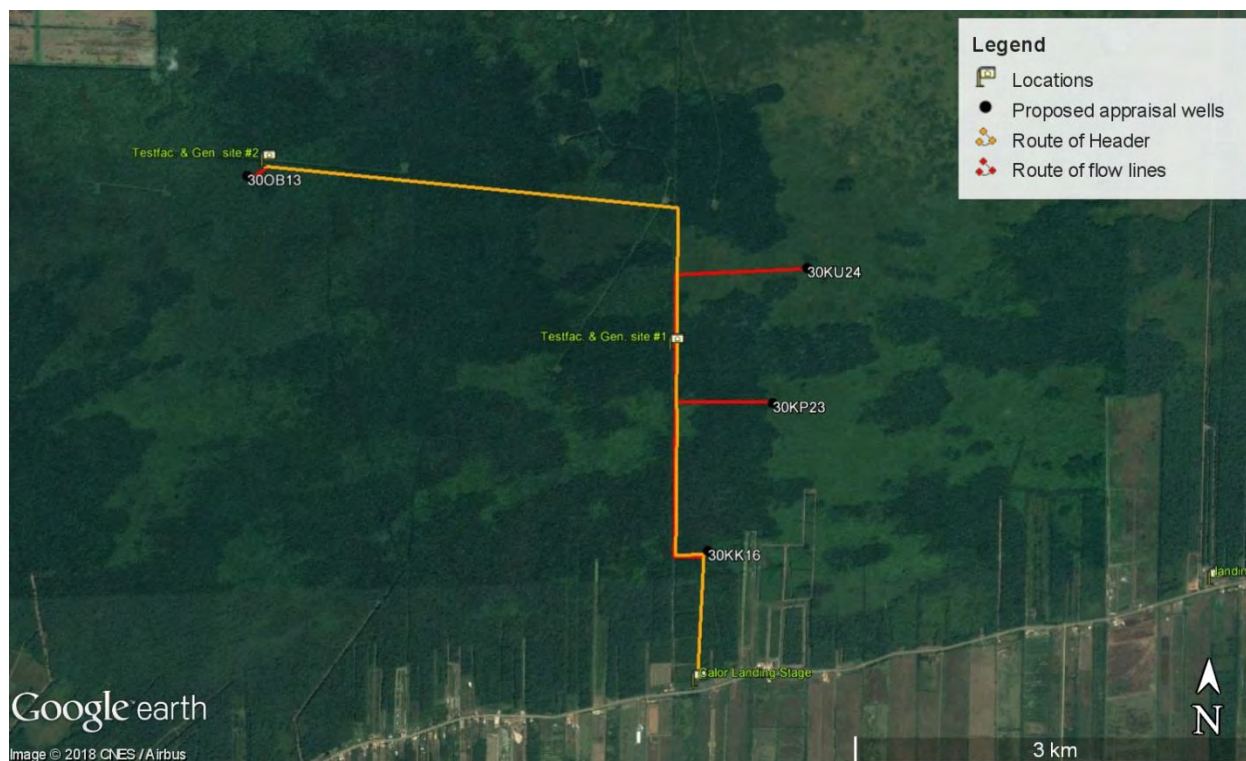
Figure 9: Overview of the route of the header to transport the crude oil from the test facilities to the collection tanks at the loading site

From the test tank and flow lines, the crude will be transported by means of a 6" header (buried at a depth of 60 cm in the dam –Figure 9) to the site with the collection/buffer tanks (4 tanks with a capacity of 90 barrels each) along the Oost-West verbinding.

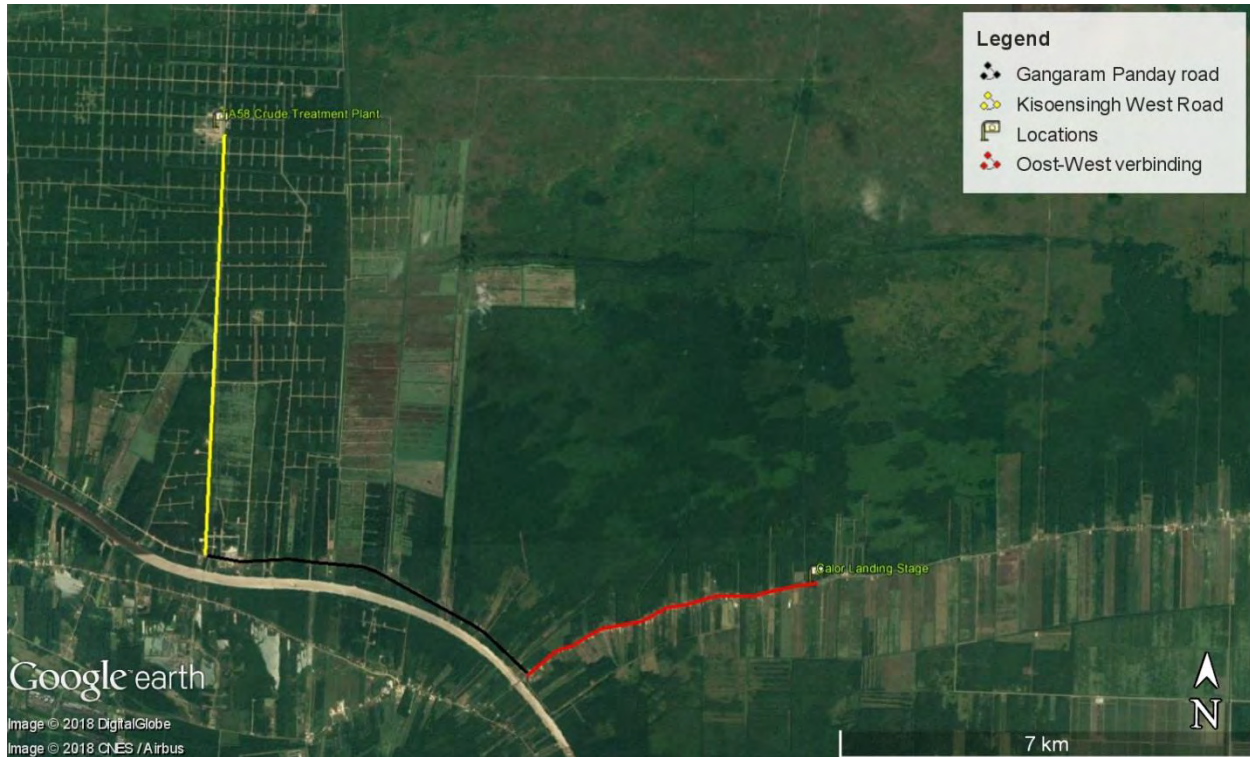
Figure 10: Route transportation of crude oil from the collection and loading site (Calor landing stage) to the TA58 crude treatment plant of Staatsolie

Daily monitoring will be conducted by 2-3 well operators and all the risk and failures of the well will be taken in consideration. In case of a mechanical or electrical failure the maintenance group will be notified. Vehicles will be used for transportation on land, while airboats will be used for the testing activities and

daily inspections of the facilities in the swamp area. Depending on the state of the Calor dam, an UTV/ATV can be used for inspection of the 6” header for alternative T1 during the dry season. However, the well locations still has to be inspected with an airboat. The Calor dam will be maintained with a mower once per month.

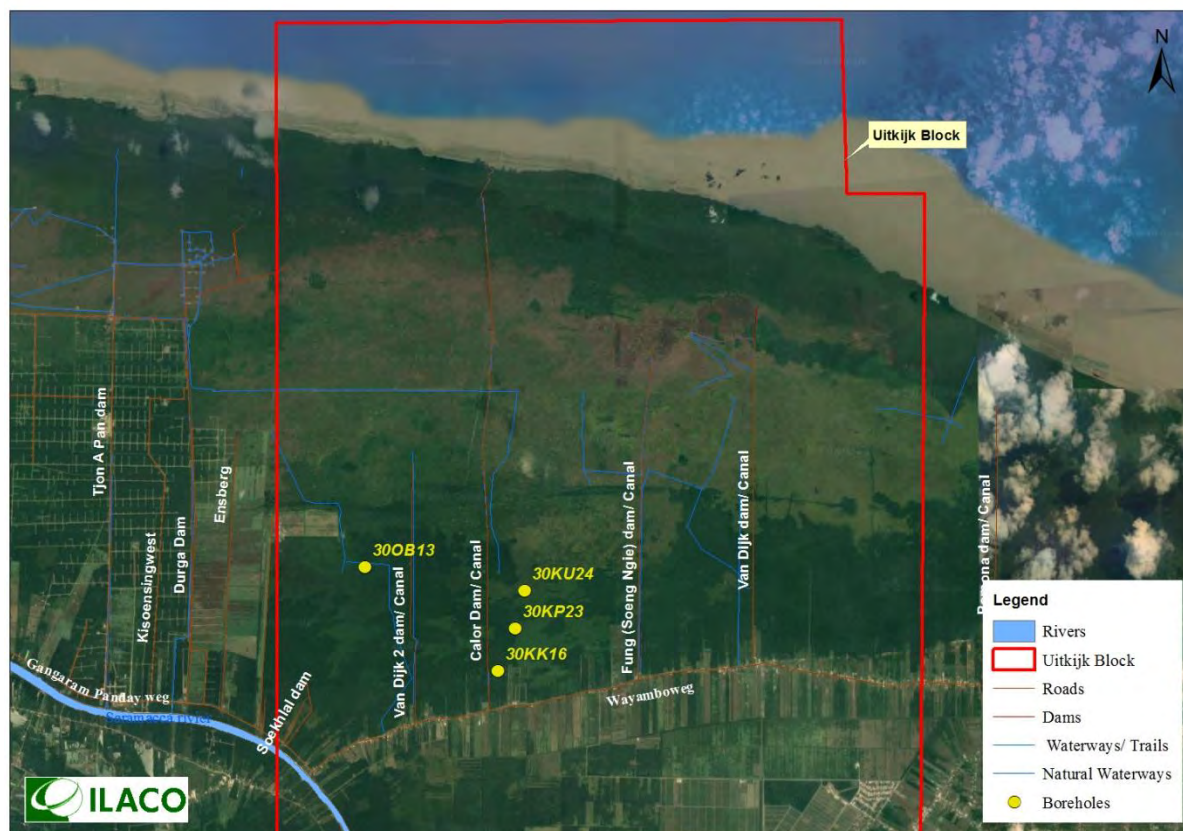
Figure 12: Project area with the planned boreholes in the Uitkijk block

The project area is situated in a swamp area with N-S canals and dams. The planned boreholes are between the Ensberg and the Soeng Ngie dam/ Canal in the Uitkijk Block (Figure 12). The northern part of the Uitkijk Block is situated in the Wayambo Swamp.

Preliminary results of this study indicate that there are no significant changes regarding hydrological conditions, so that the descriptions in earlier reports are still applicable. Important for the current project is the finding that the Calor Dam forms a barrier for water flow to the west, so that water is dammed up at the eastern side of the dam. Measurements made during the above-mentioned study indicate that the difference in water level is 20-30 cm. The higher difference is observed during dry months (February-March 2018), when the difference amounts to 30 cm. Upon the start of the rainfall in April the water level difference decreases to about 20 cm.

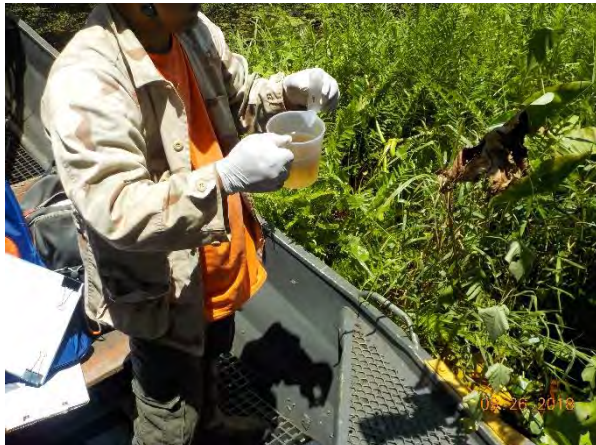
Location WQ-01: Sampling in the swamp, 33 meters away from the Calor Canal (east side). Pegasus observed in the swamp. Vegetation has been observed. No fish observed.

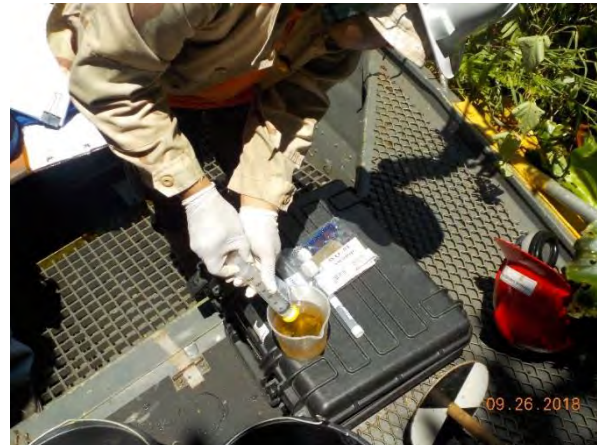
Location WQ-01: A syringe with filter (0.45u) used to filter the water sample for dissolved metal analysis

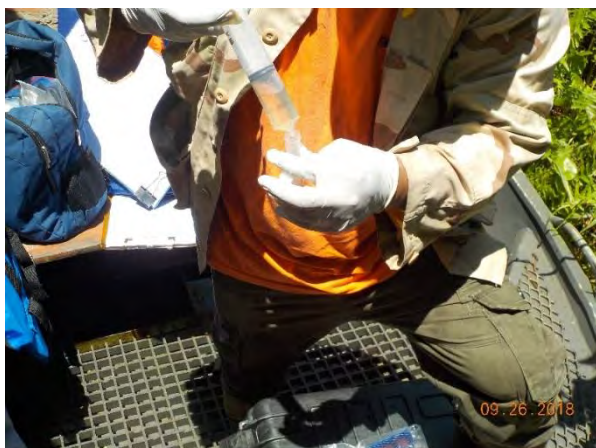
Location WQ-01: Filling the filtered water sample in a special pre-treated bottle for the Terratest analysis.

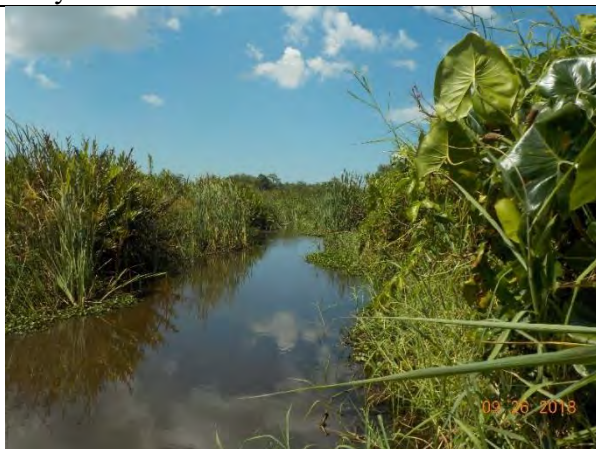
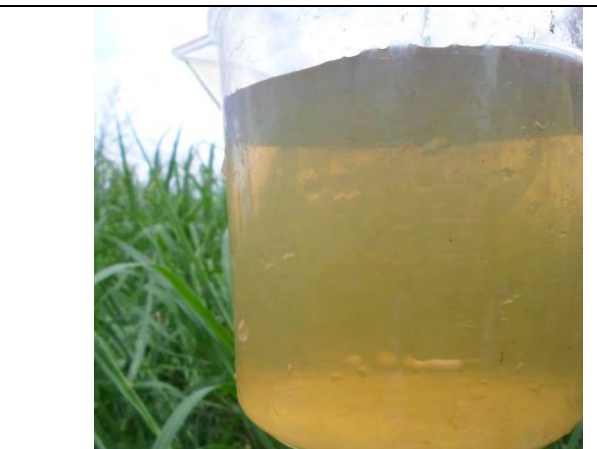
<p>Location WQ-08: In the Calor Canal (east side). Vegetation and horse grass observed in the canal. Fish observed.</p>	<p>Location WQ-08: The Calor Canal. Swamp forest. Clarity- Clear</p>

Sample ID: WQ-08	In the Calor Canal (east side). Swamp forest	674718	656330	26-09-2018	15:25 PM	5.67	483	30.05	313	3.82	28.6	0.15	27	Light brown	Clear	130	NA	Vegetation and horse grass observed in the canal. Fish was observed at the time of sampling.	
Sample ID: WQ-09	in the swamp, 9 meters away from the Calor Canal (east side). Open freshwater swamp	674598	658032	26-09-2018	14:20 PM	5.78	546	31	354	1.82	45.4	0.23	19	Light brown	Slightly turbid	20	NA	Overgrown area. Horse grass and ferns observed. At the time of sampling no fish was observed in the swamp.	
Sample ID: WQ-10	In the Calor Canal (west side). Open freshwater swamp	674584	658038	26-09-2018	14:30 PM	5.5	273	31.23	177	1.11	102	0.09	15	Light brown	Slightly turbid	76	0.33	Vegetation and fish observed in the canal at the time of sampling. Horse grass observed.	
Sample ID: WQ-11	In the Calor Canal (west side). Brackish water swamp	674485	659331	26-09-2018	14:50 PM	5.88	515	31.5	334	0.63	1392	0.22	8	Dark brown	Turbid	51	0.33	Mangrove forest zone. Vegetation and fish observed in the canal at the time of sampling.

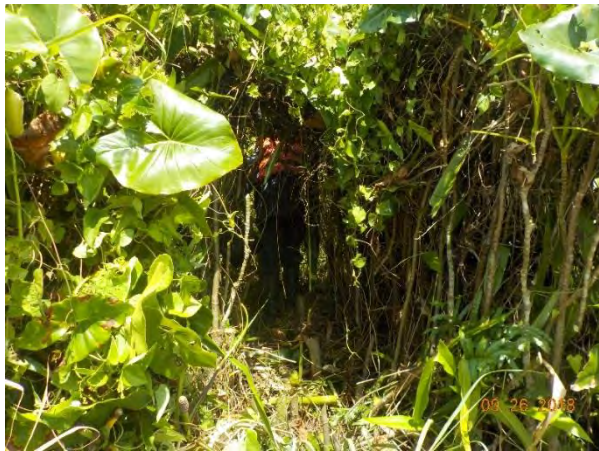
<p>Location WQ-09: Overgrown area, in the swamp, 9 meters away from the Calor Canal (east side). Horse grass and ferns observed. No fish observed in the swamp.</p>

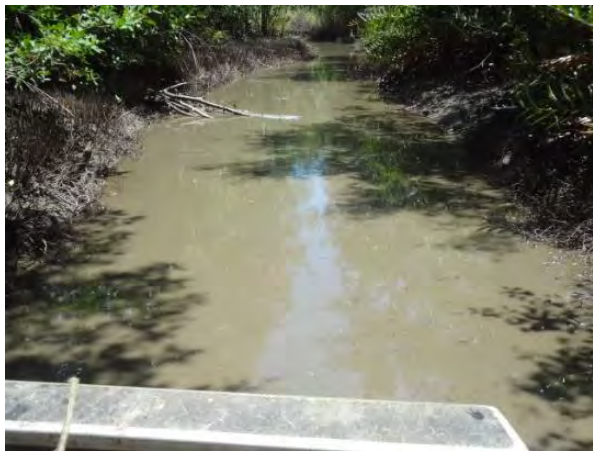
<p>Location WQ-12: In the Calor Canal (east side). Close to the coast. Mangrove forest zone. No fish observed.</p>

Sample ID: WQ-12	In the Calor Canal (east side). Mangrove zone	674582	660458	26-09-2018	15:10 PM	5.83	1760	32.43	1144	4.07	785	0.87	7	Light brown	Turbid	60	NA	Close to the coast. Cantering in the Atlantic Ocean. Mangrove forest zone. At the time of sampling no fish was observed.	
Sample ID: WQ-13 Barcode: W00035172	In the swamp, 16 meters away from the Calor Canal (west side). Swamp forest	674541	651383	3-10-2018	11:48 AM	6.58	499	28.3	324	0.53	NA	0.16	10	Light brown	Slightly turbid	20	NA	Pegasus and Moko Moko vegetation observed in swamp. At the time of sampling fish was observed. The water meter indicated an error while measuring the turbidity.

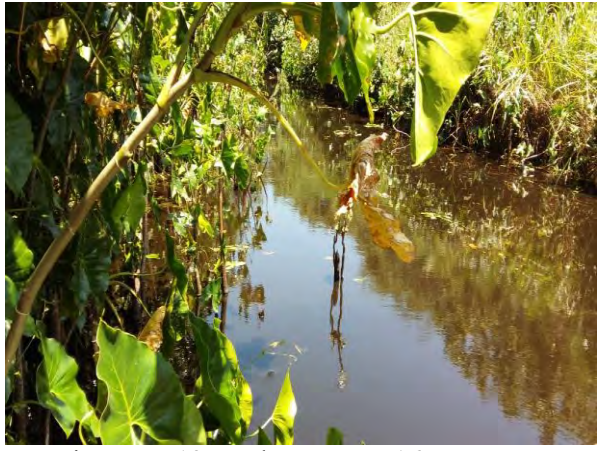
<p>Location WQ-13: In the swamp, 16 meters away from the Calor Canal (west side). Pegasus and Moko Moko vegetation observed in swamp. Fish observed in water.</p>

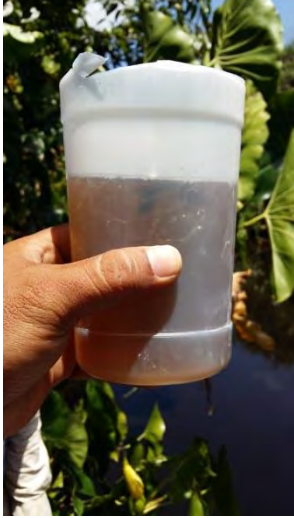
<p>Location WQ-13: In the swamp. Swamp forest. Clarity- Slightly turbid.</p>

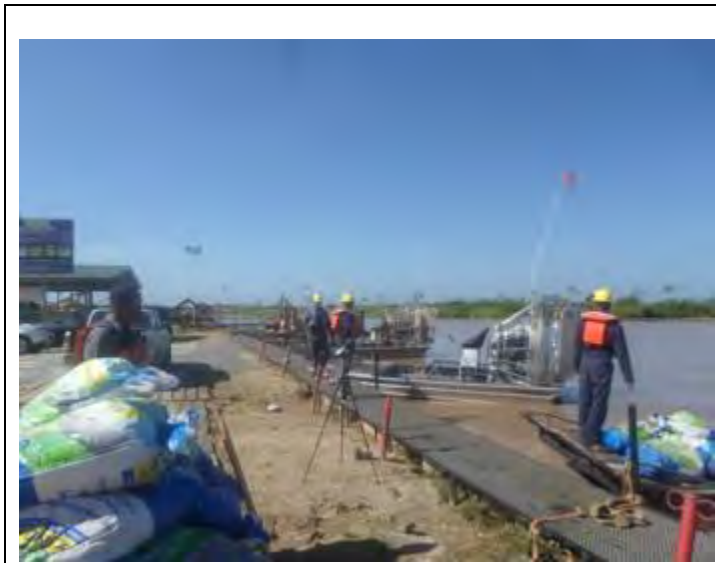
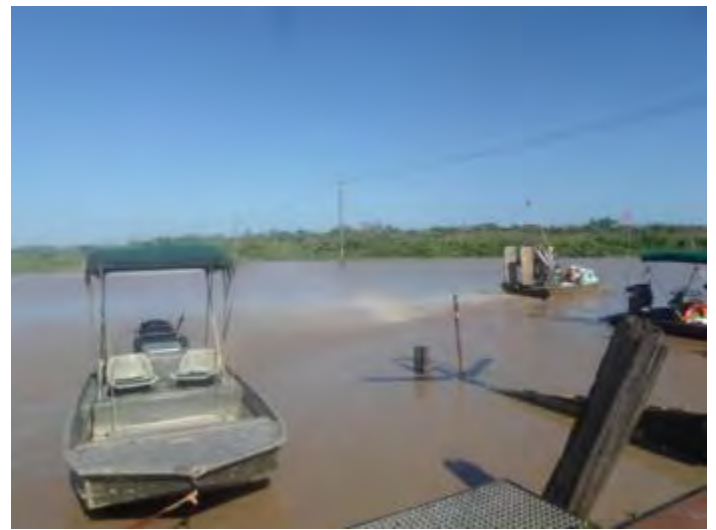
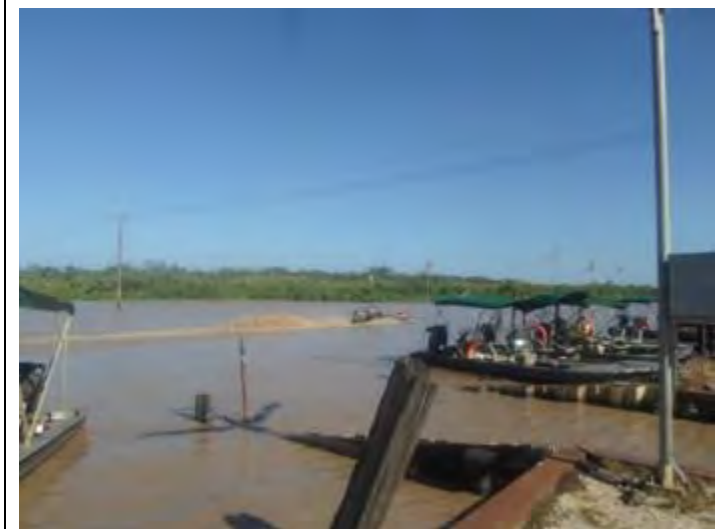
Location NU01: At the quay near the transfer station (90 m from the pump station). Airboats/boats are starting and arriving on spot. Material is being loaded on the airboats.

Location NU01: Airboat departed. Hard wind produced by the windmill of the airboat.

Location NU01: Small boat departures. Waves are produced by the boat.

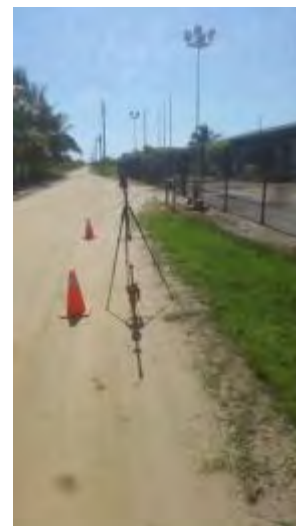
Location NU02: Along the road to the emplacement, near the pump station at a distance of 100 m from location NU01.

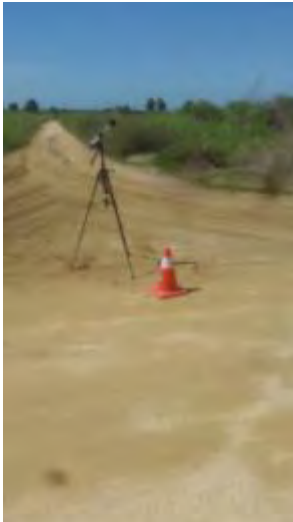
Location NU03: Along the road to the emplacement, between a T-junction, near the transfer station at a distance of 250 m from location NU01.

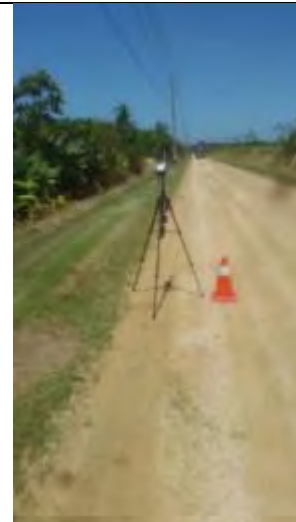
Location NU04: Along the road to the emplacement, near the transfer station at a distance of 500 m from location NU01. Vegetation observed on both sides of the road.

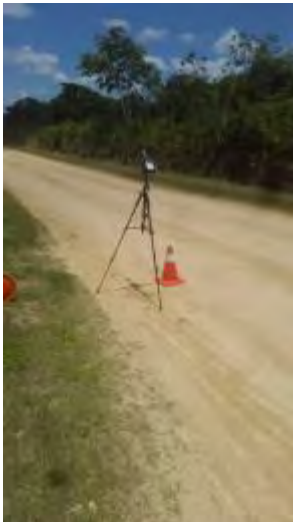
Location NU05: Along the road to the emplacement, near the transfer station at a distance of 750 m from location NU01. Vegetation observed on both sides of the road.

Under daytime as well as under nighttime conditions, a distance of 750 meter from an airboat landing is sufficient to avoid nuisance from airboat noise.

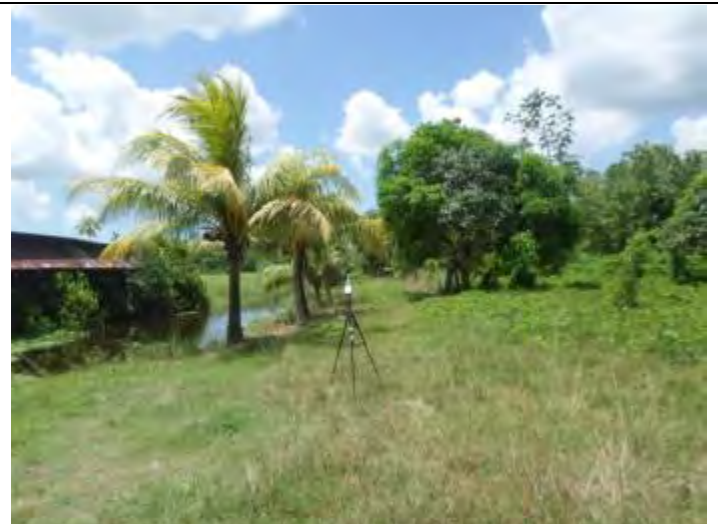
Location NU08: Calor residence. Overgrown area, on the Calor Dam. Average grass height of 0.3 meter. Distance from the axis of the road to the position of the noise meter is 200 m.

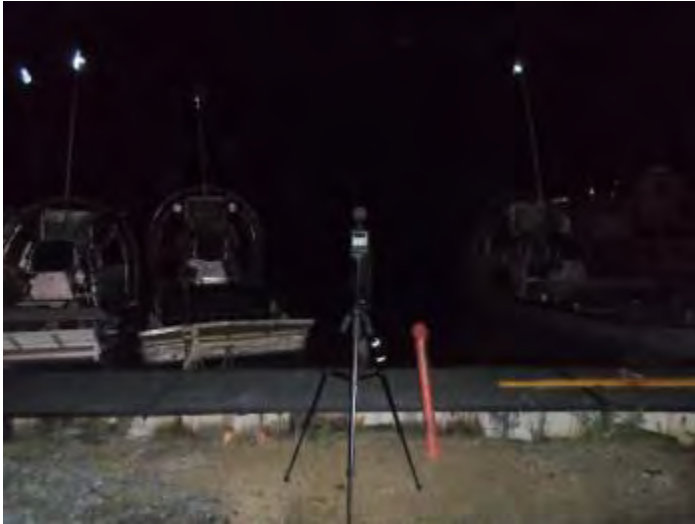
Location NU01: At the quay near the transfer station (90 m from the transfer station). All airboats are ashore.

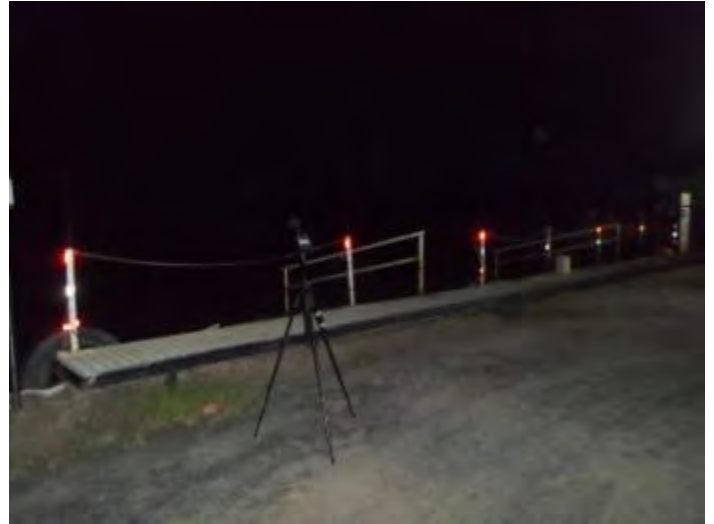
Location NU13: Near the pick-up point TNW (swamp). 1.5 km away on the north site of location NU01 and 2 m away from the quay.

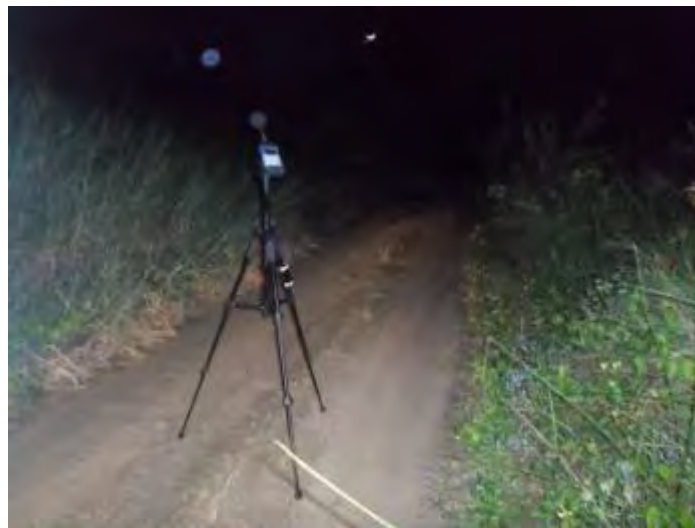
Location NU14: Along the road, near the pick-up point TNW at a distance of 750 m from location NU13.

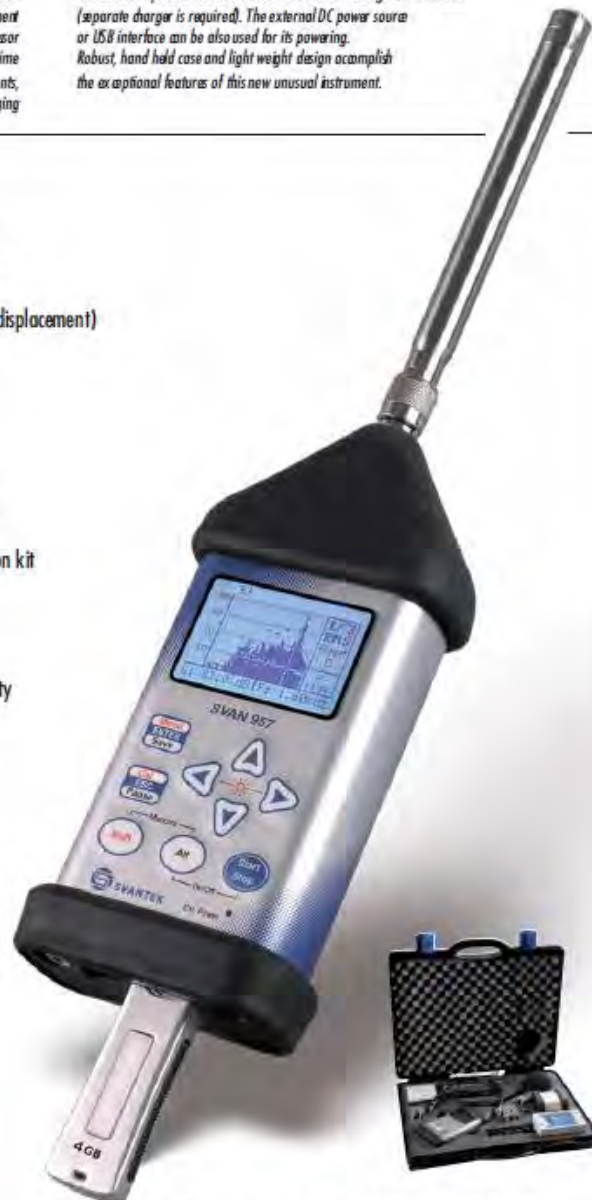
INSTRUMENTATION FOR SOUND & VIBRATION
MEASUREMENTS

- RS 232 for modems support (GPRS, Ethernet, WLAN)
- Integration time programmable up to 24 h
- Power supply by four AA rechargeable or standard batteries

- Hand held, light weight and robust case
- Easy in use

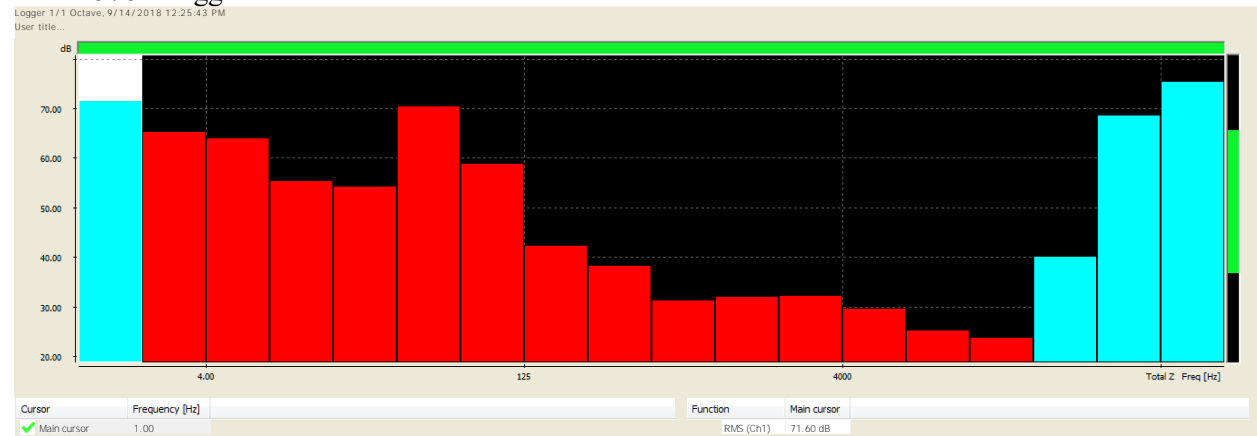
&LOG576 : Logger 1/1 Octave

Nr.	Time	Cause
1.	12:26-12:36	Constant noise of excavator/machine from the forest, noise of leaves rustling; noise of small twigs rustling
2.	12:26	Wind; noise of leaves rustling; noise of small twigs rustling
3.	12:27	Noise of birds, crickets and insects
4.	12:28	Wind; noise of leaves rustling; noise of small twigs rustling
5.	12:29	Car passing by (1x); wind; noise of leaves rustling; noise of small twigs rustling
6.	12:30	Car passing by (1x); siren alarm from Staatsolie
7.	12:31	Noise of excavator/machine sound from the forest
8.	12:32	Wind; noise of leaves rustling; noise of small twigs rustling
9.	12:33	Noise of insects
10	12:35	Wind; noise of leaves rustling; noise of small twigs rustling
11.	12:36	Wind; noise of leaves rustling; noise of small twigs rustling; noise of insects
